**RAVENNA Virtua Sound Card:  
Network Interface Driver Update  
after Windows 10 Update**

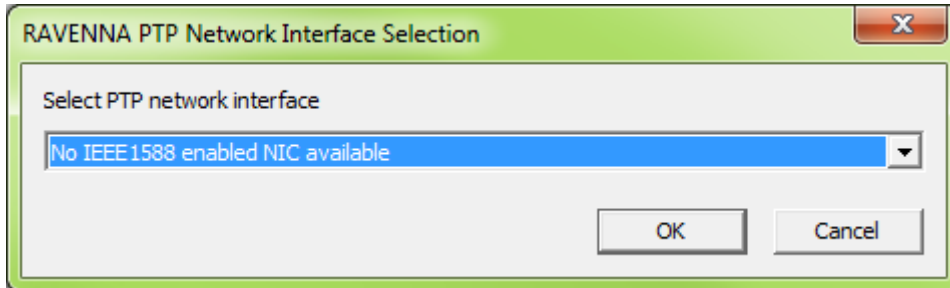
Following certain Windows 10 system updates it may be required to re-install the ALC NetworX IEEE1588-2008 network interface driver, as Windows Update routines may have reset the network interface driver setting to the original Intel driver.

A clear indicator for this requirement is the PTP icon in the task bar staying grey, with no PTP interface being selected in the RAVENNA PTP network interface selection box (right-click on PTP icon in task bar):

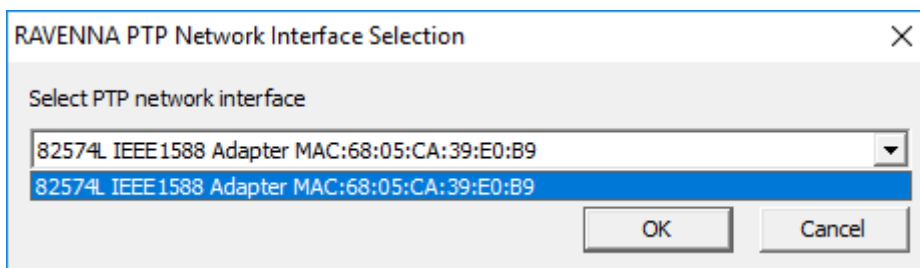
The PTP tray icon should now turn red, indicating proper PTP service initiation. After a while, it should turn green, indication PTP sync (given, that a PTP Grandmaster is present on the network and that PTP settings are properly configured – see RVSC Installation Manual for further details).

8. Hit "close", close all other Network Adapter and Center dialogs and open PTP Interface selection from the PTP icon context menu in the tray bar; select the corresponding IEEE1588 Adapter and hit "OK".
